Manhole Inspection Summary

Manhole # S55I__041MH

Location Address: **418 s conkling st**

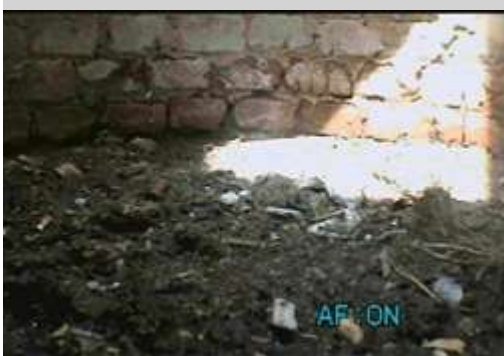
Defect 3

Condition: ☐ Sound ☐ Cracked ☐ Root Intrusion ☐ Deteriorated ☐ Leaks ☒ **Debris**

channel debris

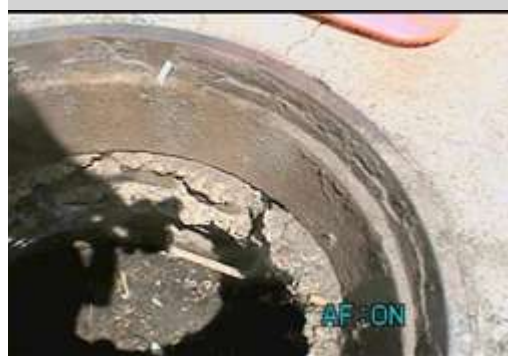
Defect 2

Frame Offset: **2** (in.) Condition: ☒ Sound ☐ Cracked ☐ Leaks

offset

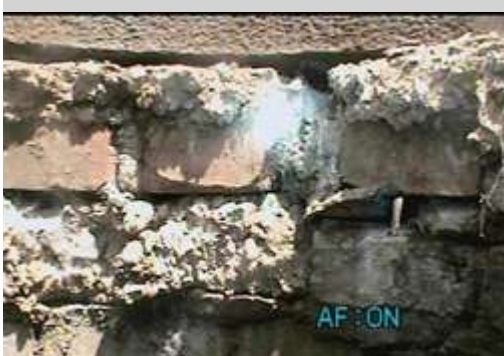
Defect 1

Condition: ☐ Sound ☐ Cracked ☐ Root Intrusion ☐ Loose Brick ☒ **Deteriorated**

Chimney deteriorated, frame adj

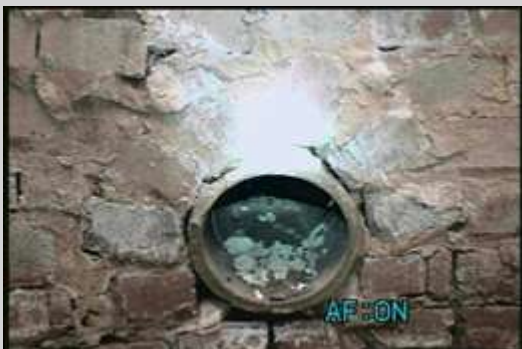
3 O'Clock Inflow

Deposits: ☐ None ☐ Mud ☐ Sludge ☒ Debris ☐ Grease

Silt Depth: 1 (in.) Deposits Extent: Light
